REPORT OF
PHASE I ENVIRONMENTAL SITE ASSESSMENT

804 and 814 PHILADELPHIA ROAD
Harford County, Maryland

May 24, 2011

GTA Project No: 110417

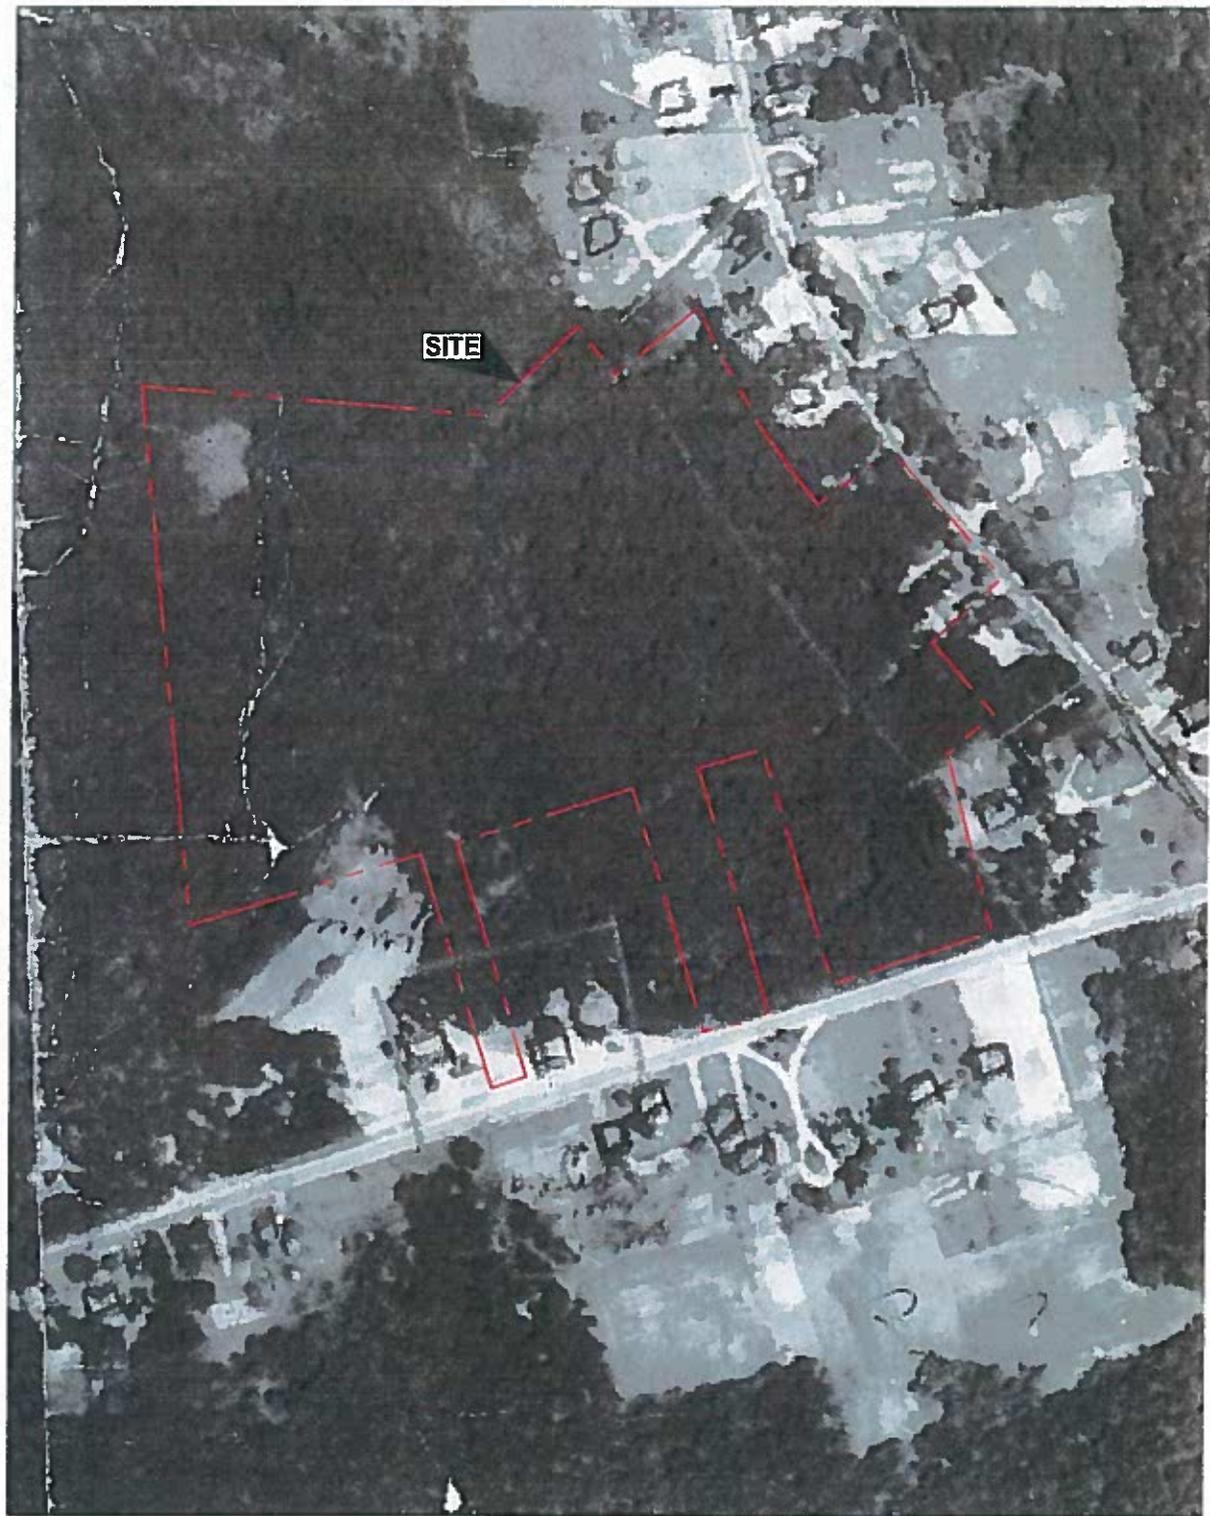
JOB NO.	110417	SCALE:	1"=300'	DATE:	MAY 2011	DRAWN BY:	JJH	REVIEW BY:	MDR	FIGURE:	4
---------	--------	--------	---------	-------	----------	-----------	-----	------------	-----	---------	---

The 1952 aerial photograph (*Figure 4*) indicates that the subject property had become mostly wooded with the same two relatively small clearings located on the northwestern and southwestern portions of the site remaining. Several apparent trails also transected the site and extended throughout the nearby site vicinity. Two apparent driveways were also observed on the eastern portion of the site, which extended from Old Mountain Road South. The area surrounding the apparent driveways was wooded; however, by 1967, several buildings were visible in this area. Based on the tree cover, however, it is unknown if the structures were present in 1952. The structure observed on the 1938 aerial photograph near the southwestern portion of the site was not observed on the 1952 aerial photograph. Additional structures had been constructed adjacent to the northern side of Philadelphia Road on adjoining southern parcels. The structures appear to consist of residences or small commercial buildings. Additional residential development, consistent with existing conditions, had also occurred in the immediate eastern and southern vicinities. Undeveloped woodlands continued to be located in the northern and western vicinities.

1952 AERIAL PHOTOGRAPH
804 & 814
PHILADELPHIA ROAD
 HARFORD COUNTY, MARYLAND

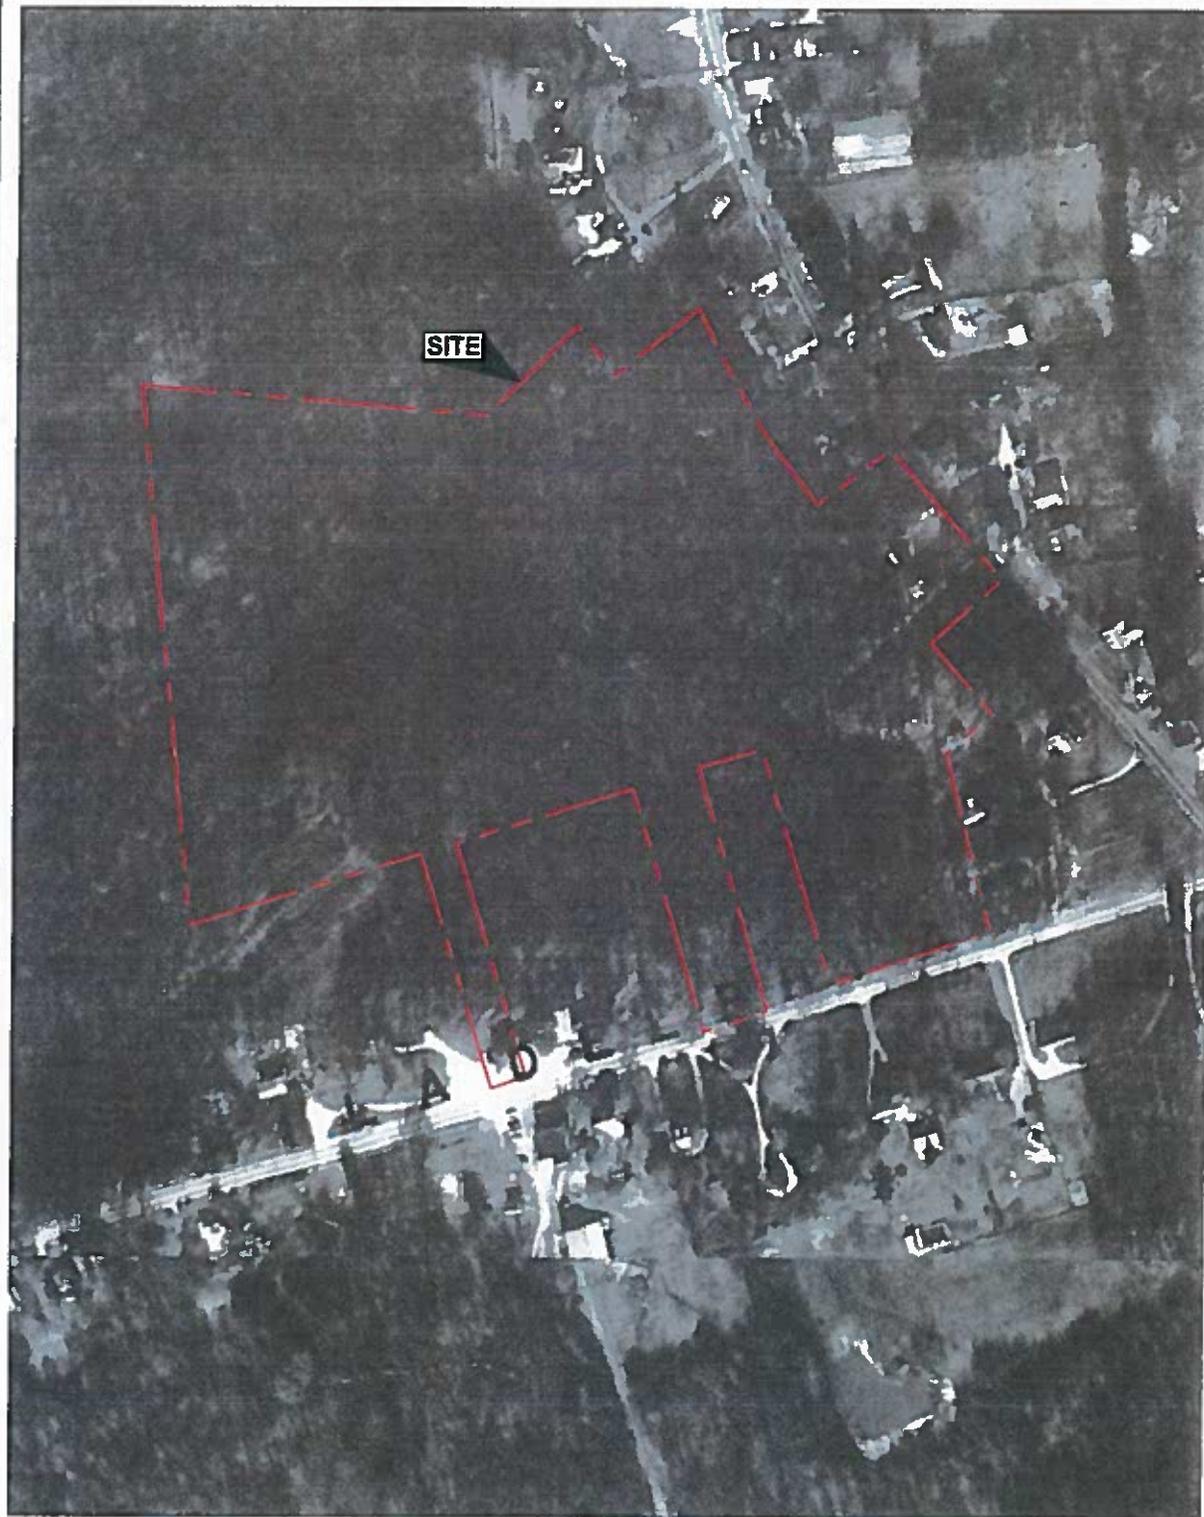
JOB NO.	110417	SCALE:	1"=300'	DATE:	MAY 2011	DRAWN BY:	JJH	REVIEW BY:	MDR	FIGURE:	5
---------	--------	--------	---------	-------	----------	-----------	-----	------------	-----	---------	---

The 1967 aerial photograph (*Figure 5*) indicates that three apparent residences had been constructed on the eastern portion of the site. The remainder of the subject property continued to primarily consist of undeveloped woodlands. Land uses in the site vicinity appeared generally consistent with those observed on the 1964 aerial photograph.

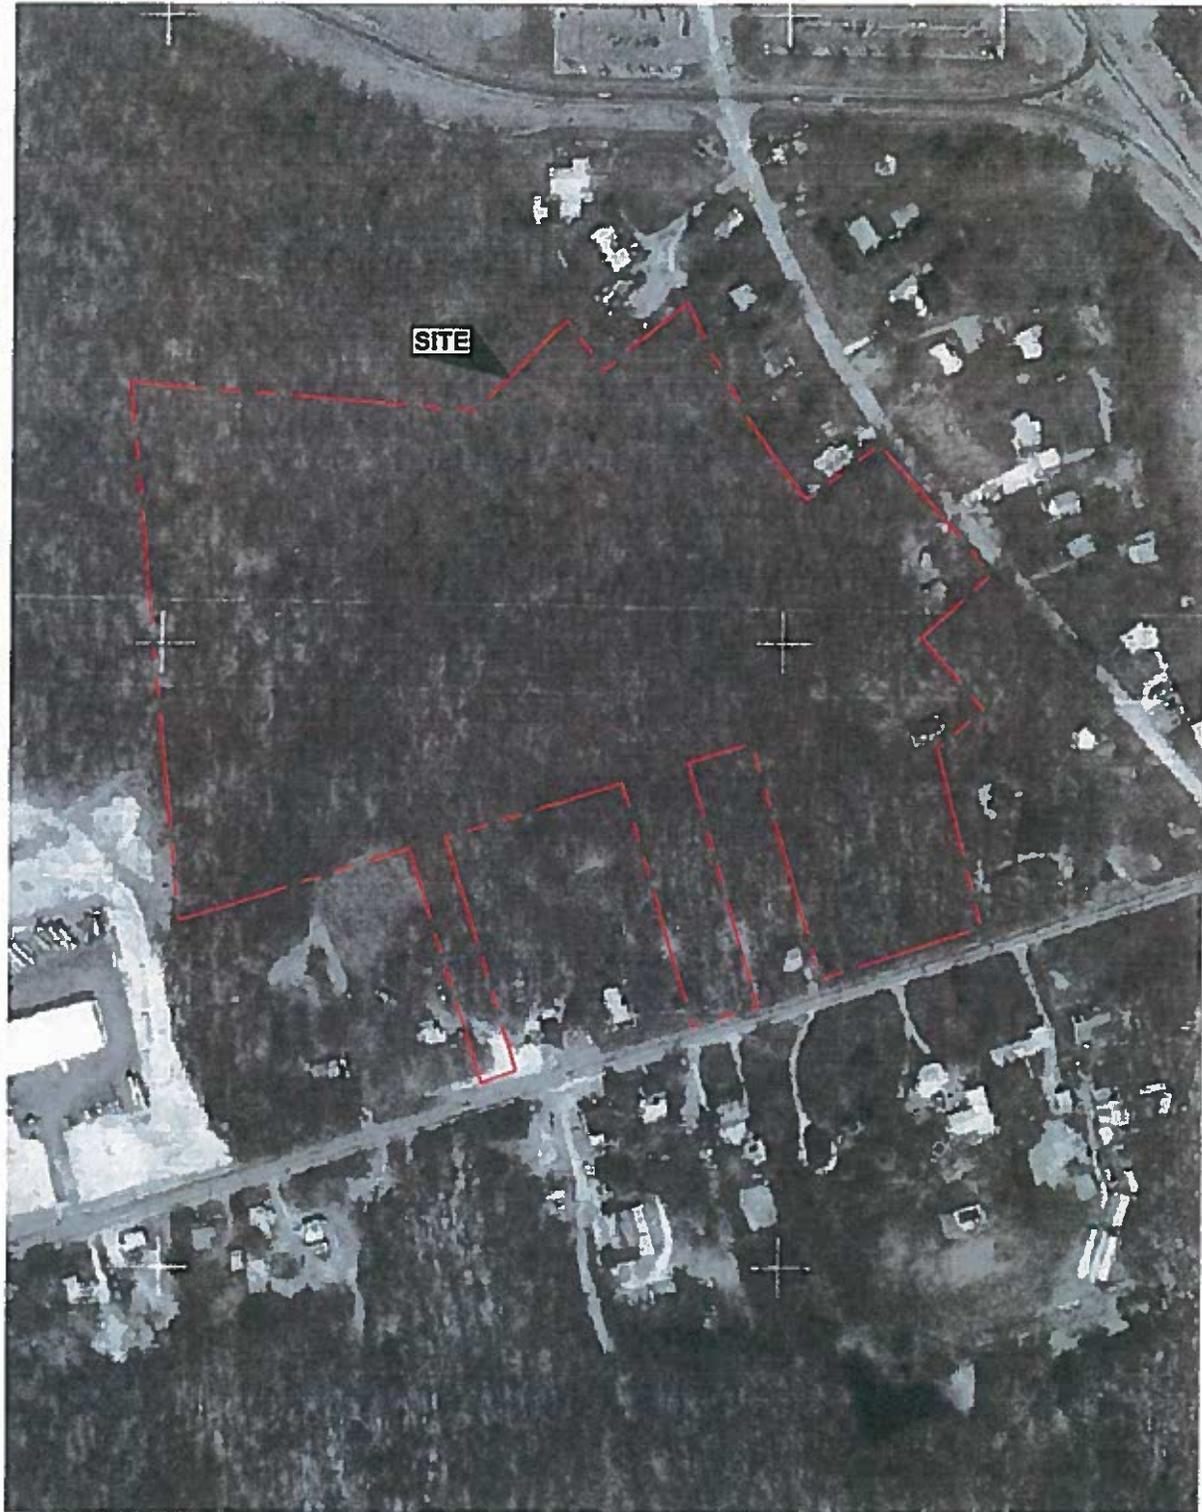
JOB NO.	110417	SCALE:	1"=300'	DATE:	MAY 2011	DRAWN BY:	JJH	REVIEW BY:	MDR	FIGURE:	6
---------	--------	--------	---------	-------	----------	-----------	-----	------------	-----	---------	---

The 1990 aerial photograph (*Figure 6*) indicates that an apparent shed or trailer had been placed near one of the residences on the eastern portion of the site. The remaining land uses on the subject property appeared generally consistent with those observed on the 1986 aerial photograph. A large commercial structure, consistent with the JB Hunt Trucking Maintenance facility, had been constructed on the adjoining western property. A second parking lot (park-n-ride) had been constructed in the northern vicinity adjacent to I-95. The remaining land uses in the site vicinity appeared generally consistent with those observed on the 1986 aerial photograph.

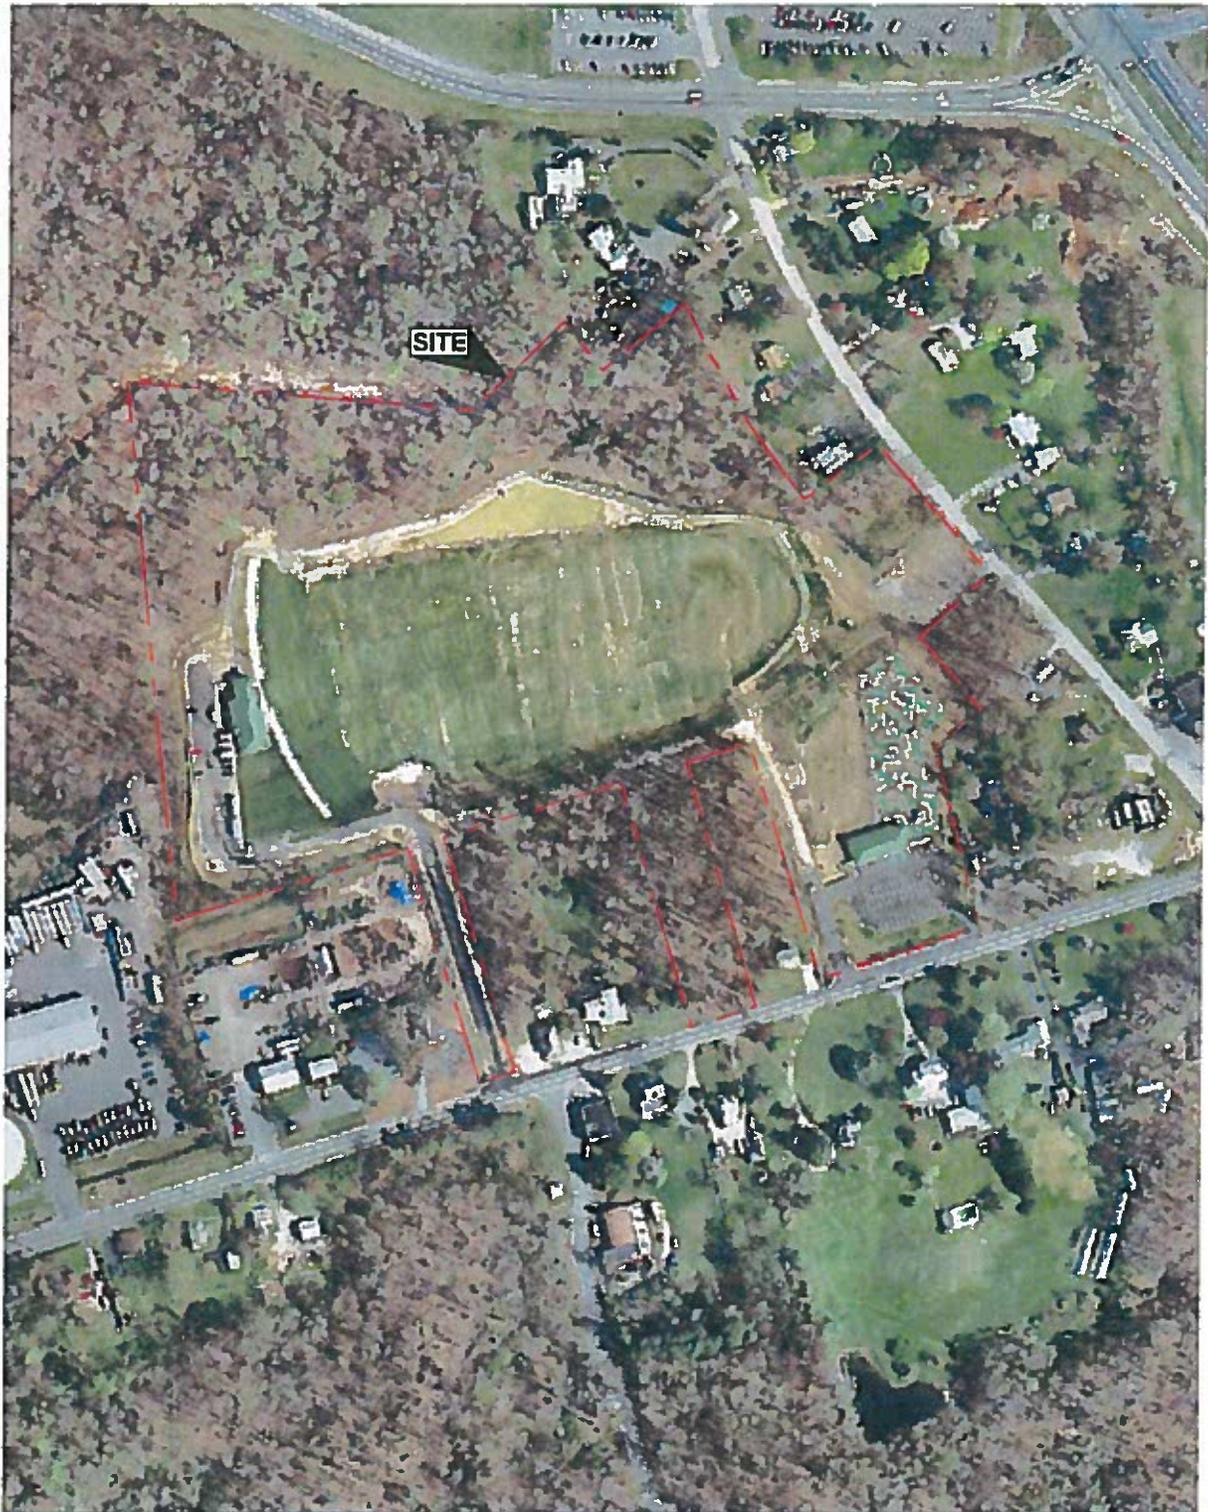
JOB NO.	110417	SCALE:	1"=300'	DATE:	MAY 2011	DRAWN BY:	JJH	REVIEW BY:	MDR	FIGURE:	7
---------	--------	--------	---------	-------	----------	-----------	-----	------------	-----	---------	---

The 2000 aerial photograph (*Figure 7*) indicates that all of the structures previously observed on the eastern portion of the site had been razed and the majority of the subject property had been cleared of woodlands and developed with the existing golf facility. The miniature golf building, miniature golf course, and the associated parking lot had been constructed on the southeastern portion of the subject property, while the golf pro shop, driving range, and SWM facility had been constructed on the general western, central, and north-central portions of the site, respectively. The Akehurst Landscaping Services facility had been constructed on an adjoining southern parcel, while a telecommunications tower had been constructed on an adjacent eastern parcel. A water storage tank had been constructed in the immediate southwestern vicinity, while the High's-Citgo gasoline station had been constructed in the eastern vicinity.

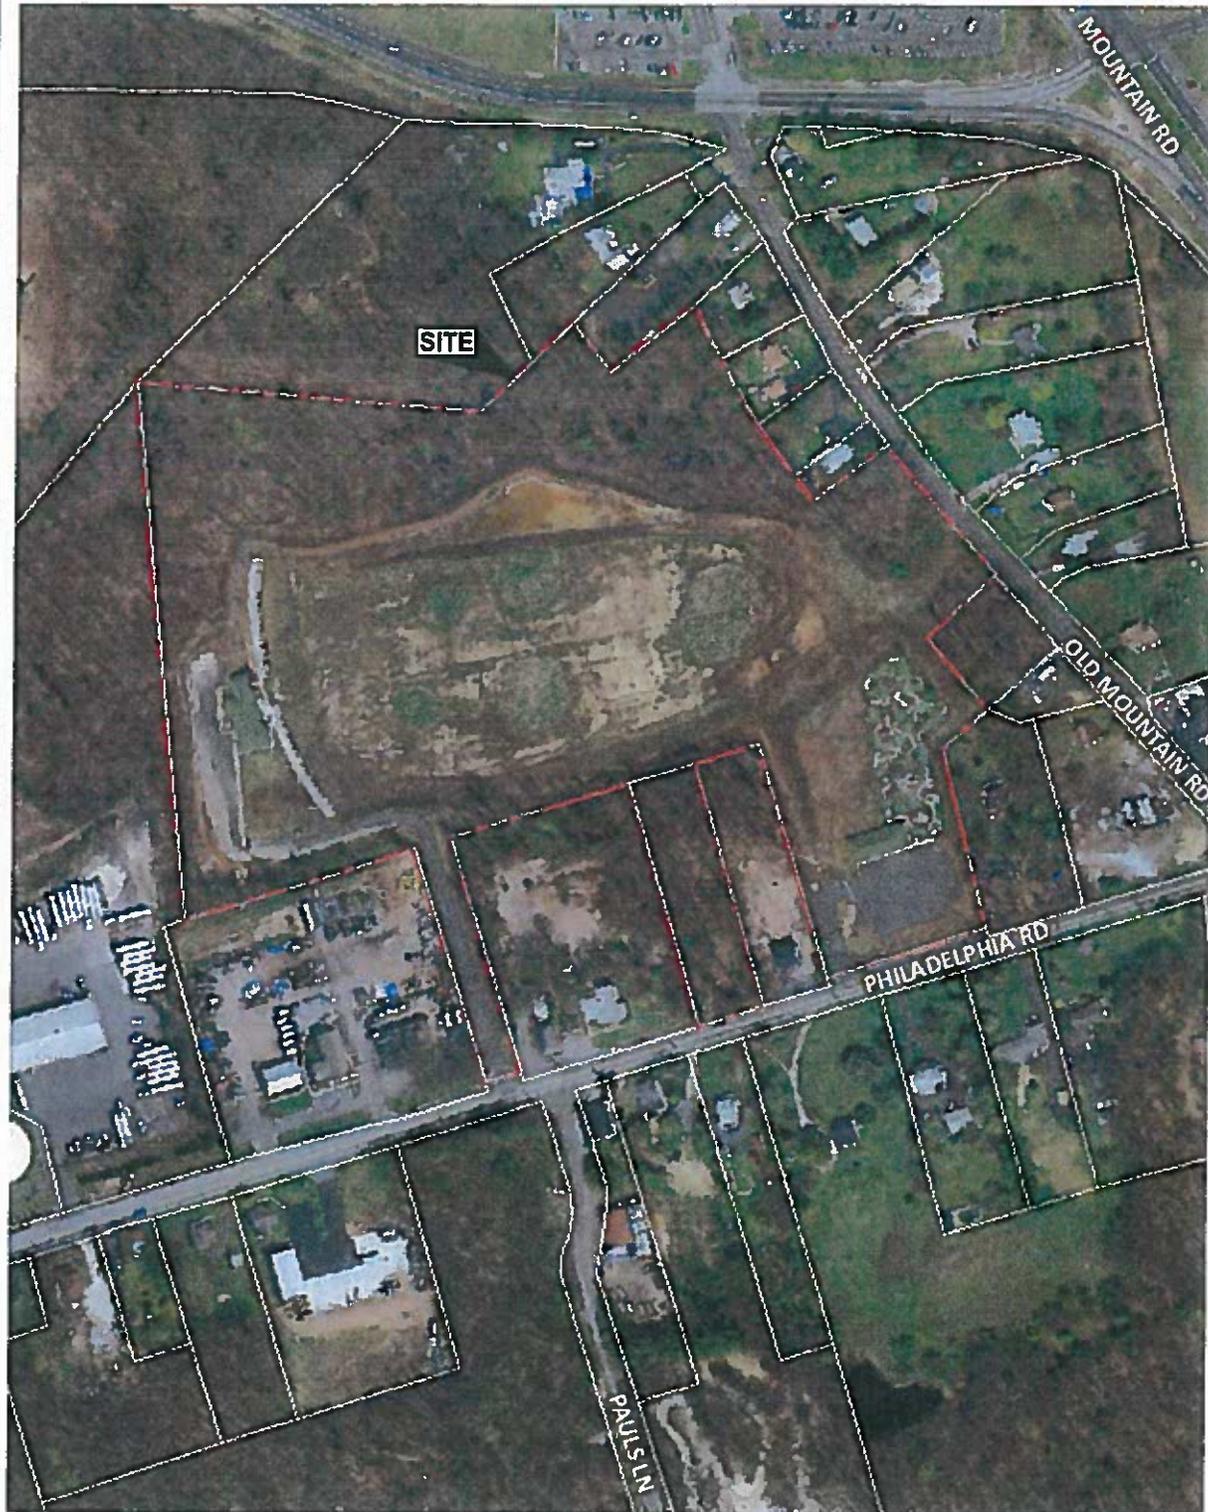
The 2004 and 2008 (*Figure 8*) aerial photographs indicate that land uses on the subject property appeared generally consistent with those observed on the 2000 aerial photograph. It should be noted that automobiles were parked at the driving range and miniature golf course in 2004, while no automobiles were present in either parking lot at the time of the 2008 aerial

photograph. The lack of automobiles suggests that the facility was vacant in 2008, which is consistent with information obtained through interviews (see *Sections 3.2 and 3.3*). The existing radio towers had been constructed in the western vicinity. The remaining land uses on the subject property and in the site vicinity appeared generally consistent with those observed on the 2000 aerial photograph.

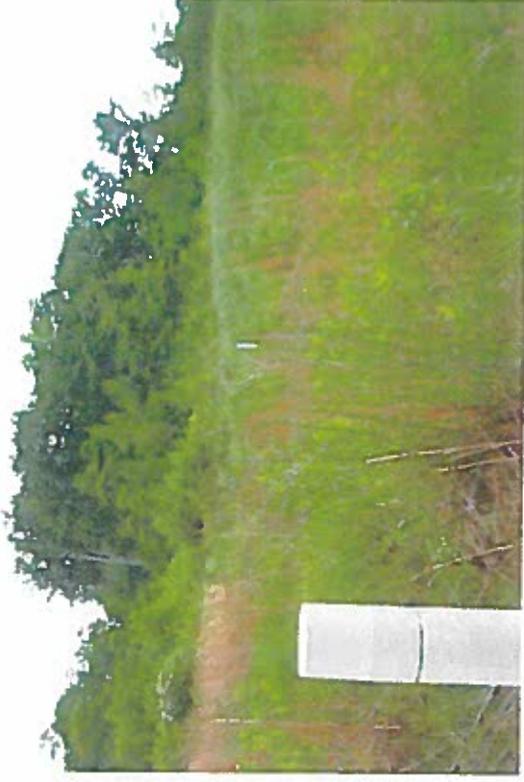
Photograph 10: View of apparent "temporary piezometers" installed by others on the eastern portion of the driving range, facing south

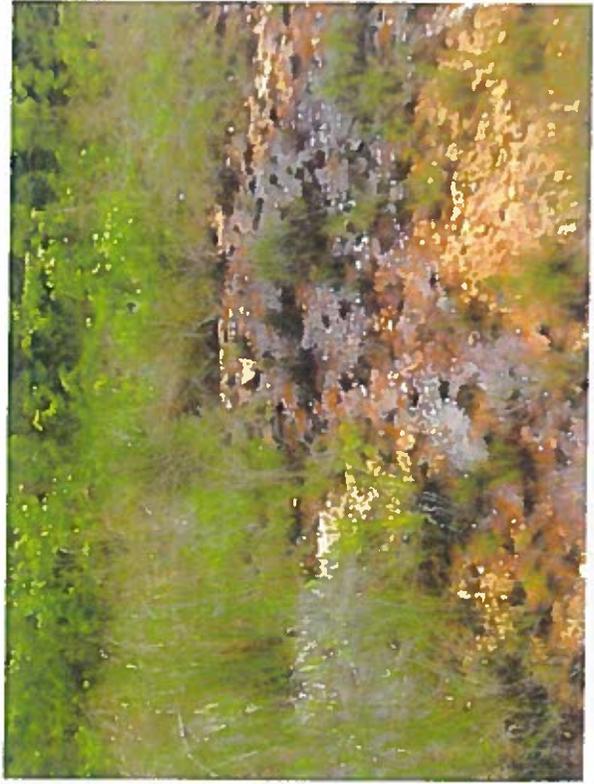
or at the off-site residence which would have caused the sheen or odor.” It should be noted that GTA personnel did not observe “ponded water” in the area described by HCEA during GTA’s site reconnaissance. Surface water was, however, observed extending from near the base of the slope at several locations in the vicinity of “discolored soil” as described by HCEA. A sheen was noted on the water and the ground surface appeared a rust color. GTA personnel did not observe a petroleum or solvent odor in the soil or water; however, an organic odor was noted. These conditions are typical of plant decay and other natural processes and are not consistent with a petroleum release.

Photograph 11: View of surface water extending from the slope on the eastern portion of the site

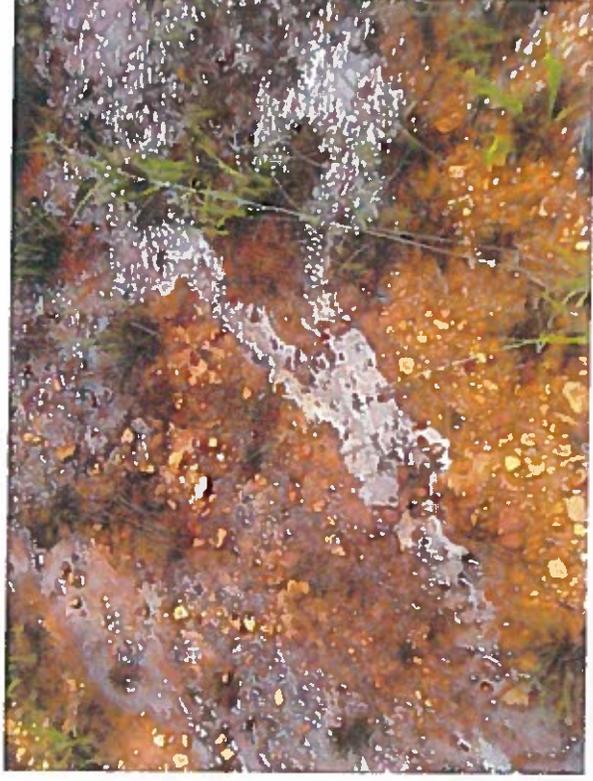
water; however, an organic odor was noted. These conditions are typical of plant decay and other natural processes and are not consistent with a petroleum release.

Photograph 12: Close-up of surface water extending from the base of the slope on the eastern portion of the site

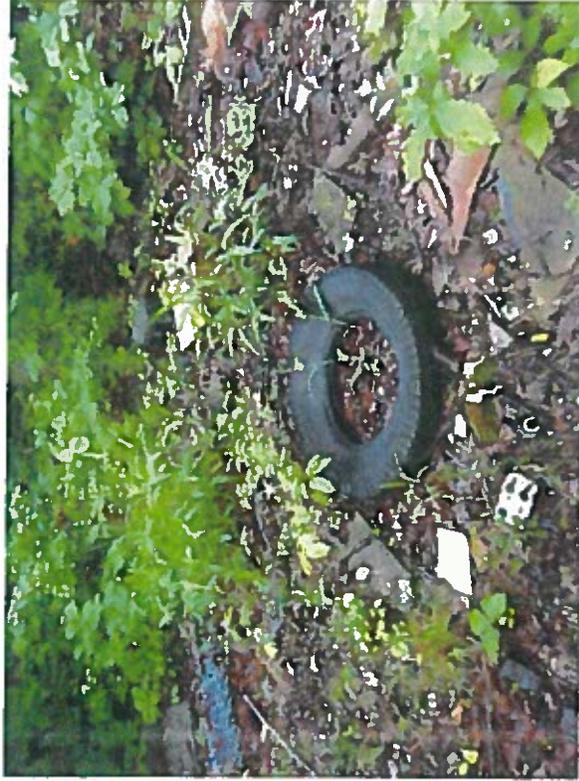
A pile of debris, which included concrete blocks, lumber, apparent roofing material, in addition to scrap metal and automotive parts, was observed within the wooded eastern portion of the site. A hand-dug well was also observed near the pile of debris. Based on a review of historic aerial photographs (see *Section 4.1*), the pile of debris and hand-dug well were located in the vicinity of several former structures. GTA personnel also observed a partially paved driveway extending onto the eastern portion of the site from Old Mountain Road South near the above referenced site features. In addition, two mailboxes, one including the address number 1412 (Old Mountain Road South), was observed adjacent to the driveway and Old Mountain Road South.

As stated in *Section 3.1.1*, a pile of debris was observed within the wooded eastern portion of the subject property. The debris appears to be related to a former structure(s) that had previously occupied this portion of the site. Additional scattered surficial debris, which included large pieces of concrete, lumber, and automotive parts, was observed within the wooded south-central portion of the site, south of the driving range. GTA personnel also observed two small areas of nuisance dumping, which included a pile of lumber and cardboard, and a pile of joint compound containers and plastic sheeting on the southeastern and eastern portions of the site, respectively.

Photograph 13: View of debris within the wooded eastern portion of the site

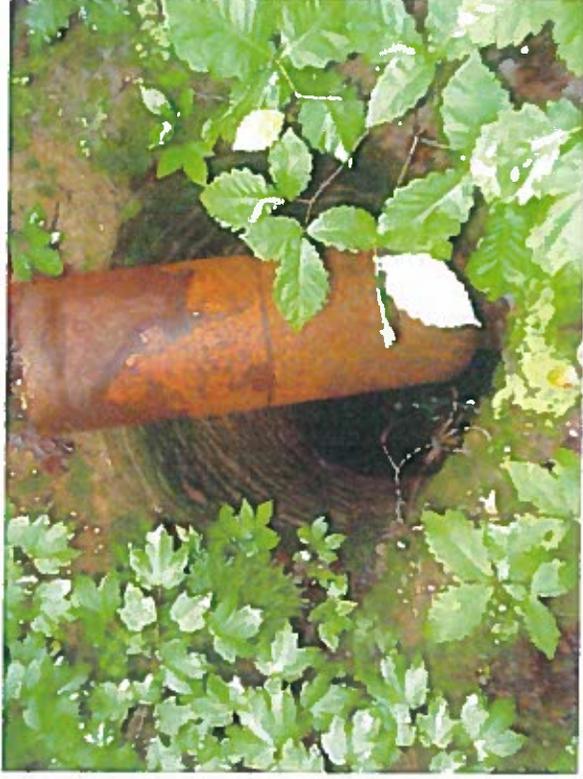
Photograph 14: View of a hand-dug well within the wooded eastern portion of the site

In addition, although not considered a REC at this time, several residences and outbuildings were previously located on the subject property and are no longer present. Such former structures may have utilized USTs for the storage of heating oil, farm fuel, or other products. GTA recommends that if buried wastes, USTs, or contaminated media are encountered during future site activities, such materials should be removed and an environmental evaluation of the area performed. GTA also recommends that the piezometers observed on the site be properly abandoned in accordance with applicable regulations.

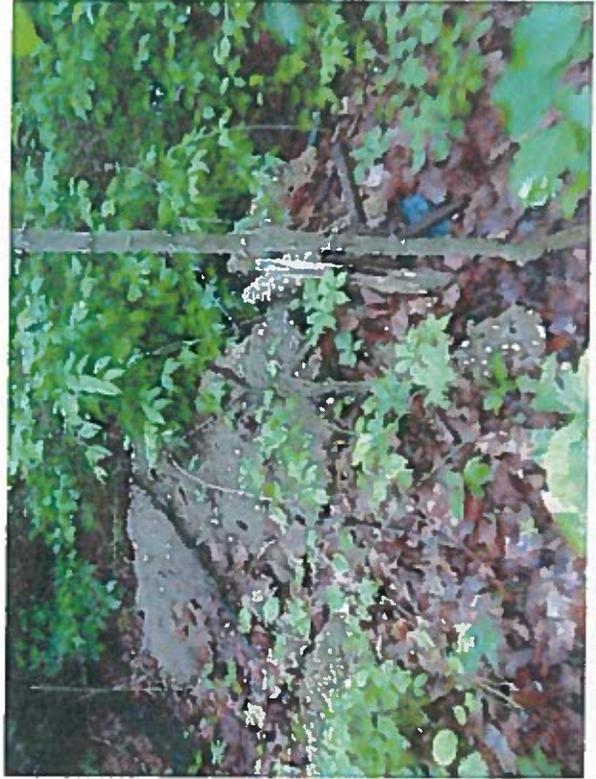
Photograph 15: View of debris within the wooded south-central portion of the site
